TREC REI 7-6

179 Lexington  
Kyle, TX 78640

# PROPERTY INSPECTION REPORT FORM

| 179 Lexington, Kyle, TX 78640<br><i>Address of Inspected Property</i> | |

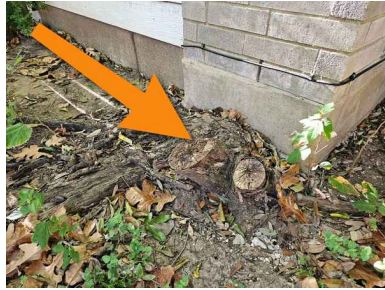
Northwest corner of house

**3: Tree stump next to structure****➡Further Evaluation Recommended**

A tree stump was found next to the structure at the time of the inspection. Tree stumps can create conducive conditions for wood-destroying insects, which may pose a risk to nearby structural components. It is recommended that a qualified contractor further evaluate and repair or replace as needed.

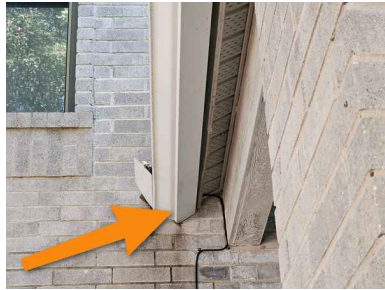
**2: Gutter: Not properly sloped / not level****🔧 Further Evaluation Recommended**

The gutter system was found to be improperly mounted / angled in one or more locations. Gutters that are not properly sloped or gutters that have negative slope may not perform as intended. It is recommended that a qualified gutter specialist further evaluate and repair as needed.

Gutter installed at an angle left of entryway

Gutter improperly sloped at front of house

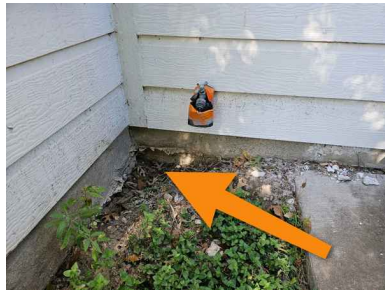
Back of house near condenser unit

**3: Low area in yard or minimal slope****➡Further Evaluation Recommended**

A low area or minimal slope in the yard was observed at the time of the inspection. Low areas or minimal sloped areas tend to be areas where water can accumulate after rainfall. Positive drainage should always be maintained and corrective measures may be needed if water remains within 10 feet of the foundation for more than a 24 hour period.

The recommended slope to help facilitate in carrying water away from the foundation is 6 inches per the first 10 feet. If a physical barrier or lot line prohibits 6 inches of fall for the first 10 feet, a swale or installation of an underground drainage system may need to be considered as an alternative solution if grading improvements cannot be made. It is recommended that a qualified contractor further evaluate and repair as needed.

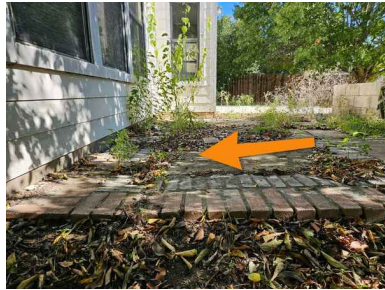
Back of house

**4: Negative grade****➡Further Evaluation Recommended**

The grade was observed to improperly slope toward the foundation in one or more locations. This can lead to water ponding near / at the foundation which can lead to adverse foundation performance over time. Any area where the grade does not slope away from the structure is to be considered an area of improper drainage.

The ideal slope is 6 inches per the first 10 feet. It is recommended that a qualified landscaper or qualified contractor regrade the affected area(s) so that the water flows away from home. The installation of an underground drainage system should be considered as an alternative solution if grading improvements cannot be made.

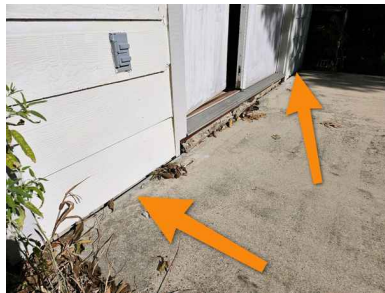
Back of house

**5: Soil / landscaping / building material: Level high at foundation**

High soil levels, landscaping or building materials were observed near the top of the foundation line in one or more locations. High soil levels, landscaping or building material may block weep holes, prevent proper wall ventilation, create conducive conditions for wood destroying insects and create an easy path for water penetration.

Under current building standards, it is recommended that 4 inches of foundation be visible below masonry veneer and 6 inches of foundation be visible below a wood type veneer. Too little soil can result in erosion under the foundation and can lead adverse foundation conditions. Correction of soil and/or building material is recommended at this location.

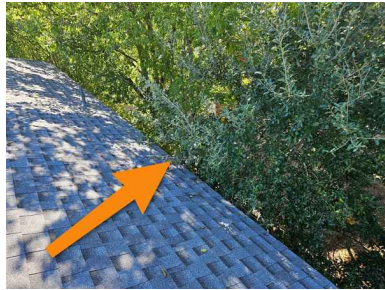
Various locations at south side of house

**1: Foliage: In contact or close proximity to roof covering material****➡ Further Evaluation Recommended**

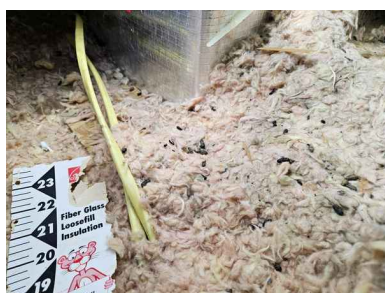
Evidence of rodent other animal activity was observed in one or more locations in the attic area. It is recommended to make sure that all eaves, frieze boards, chimney areas, etc. are properly sealed in order to reduce rodent / animal like activity in the attic space and to monitor these areas for any changes. It is recommended that a qualified contractor further evaluate and repair or replace as needed.

Rodent droppings at various locations  
in attic area

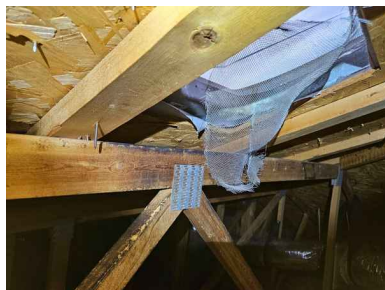
A roof vent screen in one or more locations was found to be damaged at the time of the inspection. Screens at vents help reduce insect and rodent intrusion. Damaged roof vent screens may not perform as intended. It is recommended that a qualified contractor further evaluate and repair or replace as needed.

Multiple screens damaged at roof vents  
in attic area

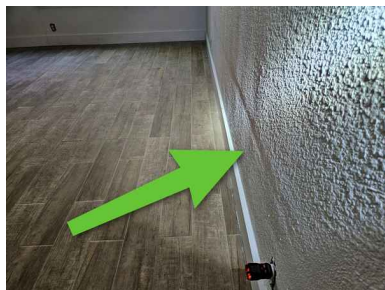
Evidence of previous patching, repair and/or painting to the drywall finish material was observed in one or more locations. The repair can limit the inspector's ability to render accurate opinions to the previous condition prior to repair. It is recommended that the buyer try to learn more about the patching, repair and/or painting from the seller prior to closing.

Lower section of drywall previously repaired at lower level of house

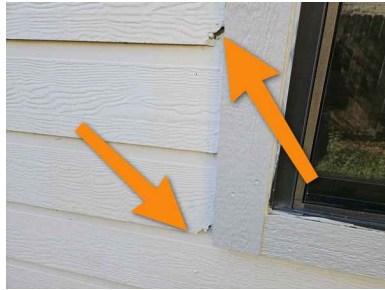
Multiple locations

Siding was found to be deteriorated and/or damaged in one or more locations at the time of the inspection. Deteriorated or damaged siding should be repaired to prevent further damage, reduce chances of moisture penetration and reduce chances insect intrusion at these locations. It is recommended that a qualified contractor further evaluate and repair as needed.

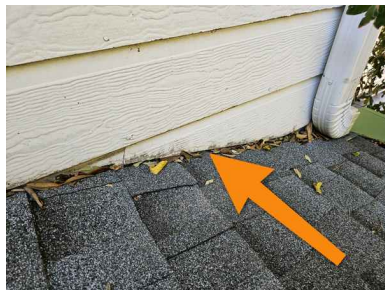
Above entryway

At the time of the inspection, exterior siding or trim was found to be in contact or in very close proximity to the roof covering material. When exterior siding or trim is in contact with the roof covering material, moisture can begin to wick up into the siding which may lead to deterioration and/or shorten the lifespan of the siding material. A small gap that provides adequate clearance is recommended between the two building materials. It is recommended that a qualified contractor further evaluate and repair as needed.

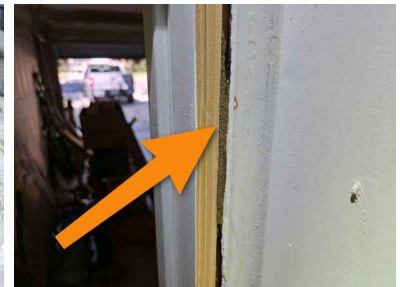
Mud tubes in wall at water heater closet

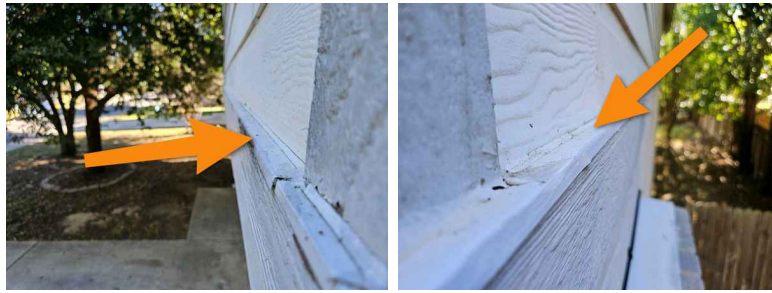
Z flashing negatively sloped at multiple locations

It is recommended that a qualified contractor further evaluate and repair or replace as needed.

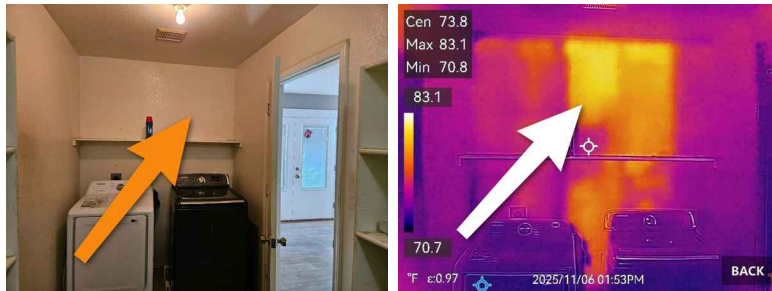
Utility room

One or more areas of a wall appeared to have insulation that was missing, inadequate or improperly installed at the time of the inspection. Insulation that is missing, inadequate or improperly installed may allow greater than normal loss of energy from inside the home. Walls from a conditioned space to an unconditioned space should be properly insulated. It is recommended that a qualified contractor further evaluate and repair as needed.

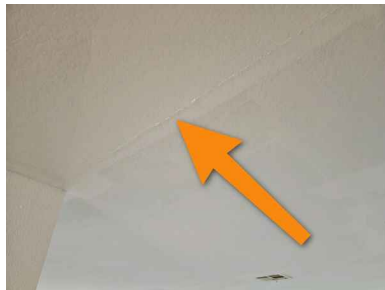
Multiple locations

Small cracks were observed in the drywall at one or more location. Minor cracks in the drywall can be an indication of expansion and contraction of building materials or that there is or was some degree of movement or settling occurring in the structure. It is recommended to repair the cracked area(s) and to monitor for continued movement. If continued cracking is observed, it is recommended to have a licensed structural engineer further evaluate.

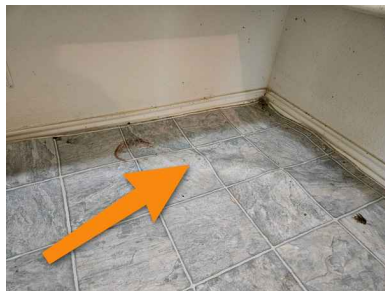
Pantry

Damaged flooring material was observed in one or more locations at the time of the inspection. It is recommended that the flooring be repaired by a flooring specialist or qualified contractor.

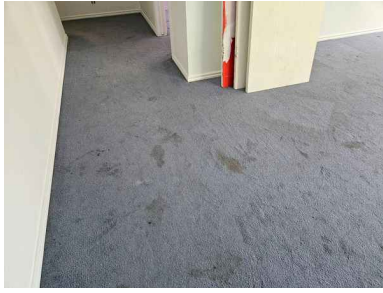
Staining throughout upstairs carpeting material

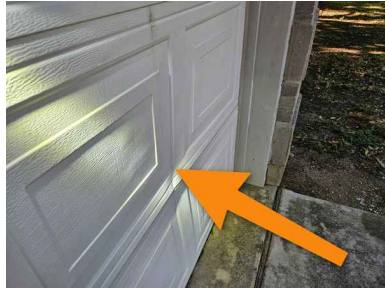
Garage door

A door was found to be damaged in one or more locations at the time of the inspection. Damaged doors should be repaired to prevent further damage to the door and surrounding material and if leading to the exterior, reduce moisture penetration and reduce insect intrusion at these locations. It is recommended that a qualified contractor further evaluate and repair or replace as needed.

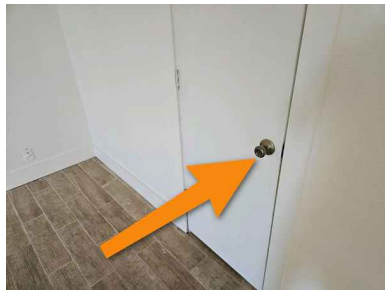
Door to downstairs half bathroom

One or more doors were found to not properly latch when closed. Doors that do not latch properly can usually be adjusted to properly latch. Continued improper latching of doors may be an indication of a movement or settling of the structure or seasonal conditions. It is recommended that a qualified contractor further evaluate and repair or replace as needed.

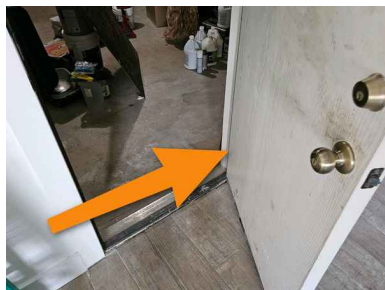
Door to garage

The self closing hinge for the door at the garage was missing or not properly functioning. The garage door that provides access to the conditioned dwelling must be fire-rated, have weather stripping installed at the door jamb/casing and have a self close mechanism for safety purposes. It is recommended that a qualified contractor further evaluate and repair as needed.

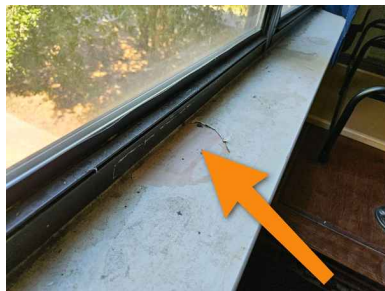
Sills at multiple bedroom windows

**NOTE: Condensation is common at these locations when aluminum framing is present.**

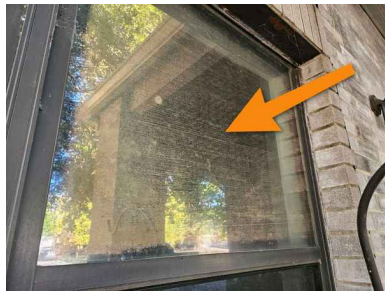
Lower window at entryway

When a thermal seal is lost, condensation will typically develop between the panes of glass which can cause discoloration or fogging. Discoloration or fogging may appear and disappear as humidity and temperature change during the seasons. It is recommended that a qualified window specialist or qualified contractor further evaluate and repair or replace as needed.

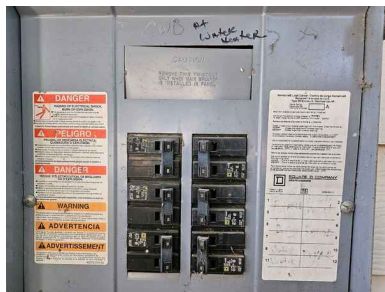
*Pre 2020 NEC change: Terminal covers not present at main panel:*

Covers or barriers should be installed at the service entrance terminals to prevent inadvertent contact by persons or maintenance equipment while servicing load terminations.

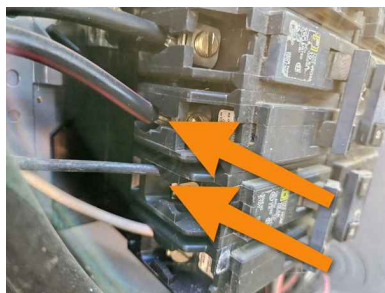
Main panel

### 1: Antioxidant gel / paste: Missing

Missing antioxidant gel/paste was observed on the exposed aluminum conductor terminations. It is common for larger wires (especially service wires from the municipalities) to be aluminum however aluminum wires can become hot and corrode over time. Antioxidant gel should be applied at these connections to help reduce oxidation that can occur over time.

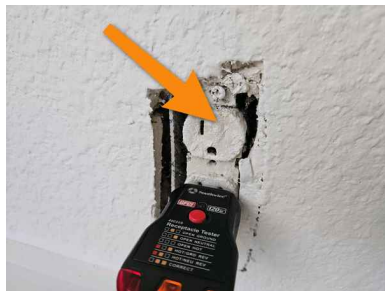
Near back door

One or more receptacles were found to be partially obstructed by a foreign object or debris. Partially obstructed receptacles may prevent proper use of electrical devices. It is recommended that a qualified, licensed electrician further evaluate and repair or replace as needed.

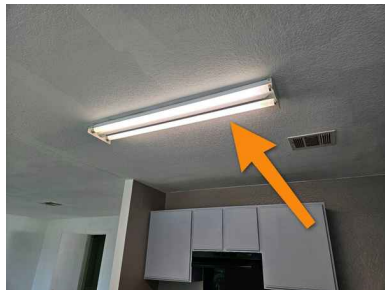
Kitchen

At the time of the inspection, a light fixture cover was found to be missing in one or more locations. Light fixture covers help protect light bulb(s) and wiring from outside contact. It is recommended that a qualified contractor further evaluate and repair or replace as needed.

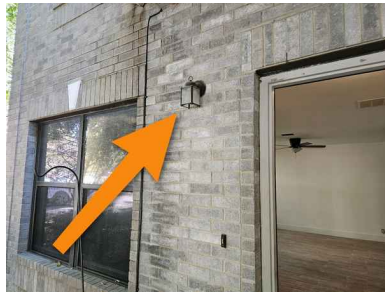
Entryway

One or more light fixtures or bulbs were found to not operate as intended in one or more locations. This may be attributed to not locating the correct light switch, a bulb needing replacement, a light fixture in need of repair / replacement, a light being on a dawn / dusk sensor, remote not located or present, improper or damaged wiring, faulty breaker or other reasons. It is recommended that a qualified, licensed electrician further evaluate and repair as needed.

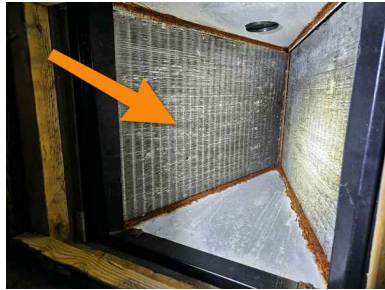
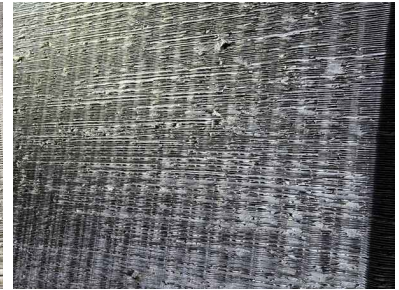
Damaged fins at evaporator coil in  
HVAC closet - photo 1

Damaged fins at evaporator coil in  
HVAC closet - photo 2

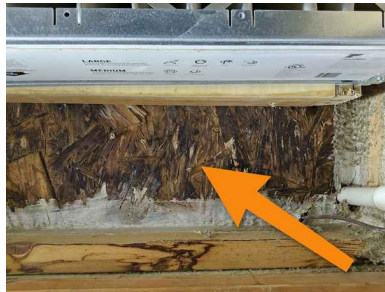
Below HVAC unit looking up

Evidence of previous water penetration or discoloration was observed on the decking material near the HVAC unit in the attic. Water penetration/discoloration may be an indication of a previous roof covering material defect(s), a leak at the HVAC system or another issue. While the area did appear to be dry at the time of the inspection, it is recommended that a qualified contractor further evaluate, identify the moisture/water source, correct the condition and repair the damaged area. It is also recommended to closely monitor this area after corrections have been completed.

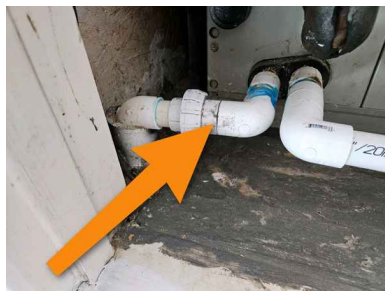
At HVAC closet

The insulation on the primary condensate drain line that runs from the coil housing was observed to be missing in one or more areas at the time of the inspection. Properly insulating the drain line will help to prevent moisture from building on the exterior of the drain line and reduce the chances for leaking condensate on the outside of the line due to the very cold condensate leaving the evaporator coil.

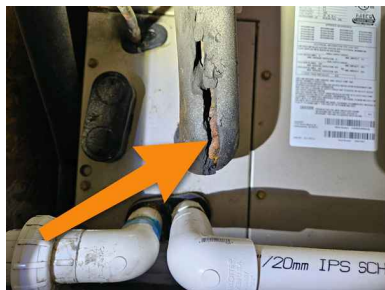
Front of HVAC unit

At the time of the inspection, insulation at the refrigerant line was found to be damaged. Refrigerant lines at HVAC units can reach cold temperatures and will produce condensation if not properly insulated. Properly insulated refrigerant line can improve performance, help to prevent moisture from building on the exterior of the line and help reduce the chances of dripping condensate. It is recommended that a qualified, licensed HVAC technician further evaluate and repair or replace as needed.

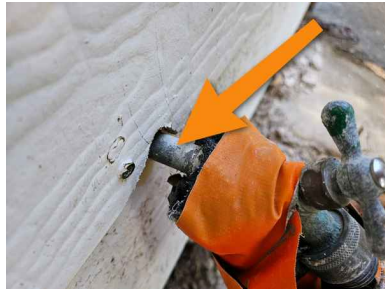
Exterior hose bibs

The insulation of the exterior water line was found to be damaged, missing or improperly installed at the time of the inspection. Exposed exterior water lines should be properly insulated in order to help reduce the chances of the water line freezing during cold temperatures. It is recommended that a qualified, licensed plumber further evaluate the condition of the exposed pipe(s) in this location and insulate as needed.

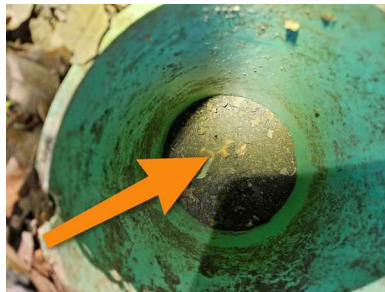
Near water meter

The shutoff valve for the main water supply line was found to be buried at the time of the inspection. Water supply shut off valves should be easily accessible in the event the water should be shut off due to an emergency. It is recommended that the dirt/debris be removed so that the valve can easily be accessible.

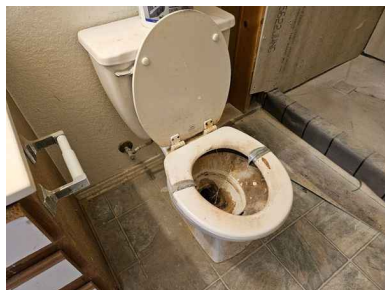
Primary bathroom

A toilet was found to be loose, damaged or not properly installed at the time of the inspection in one or more locations. It is recommended that a qualified contractor further evaluate are repair or replace as needed.

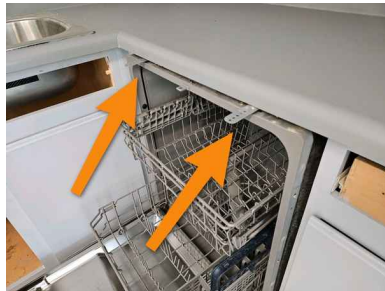
The dishwasher was observed to be loose or not properly secured or mounted at the time of the inspection. It is recommended that a qualified contractor properly mount and secure the dishwasher to prevent damage or tipping.
