TREC REI 7-6

179 Lexington  
Kyle, TX 78640

# PROPERTY INSPECTION REPORT FORM

| 179 Lexington, Kyle, TX 78640<br><i>Address of Inspected Property</i> | |

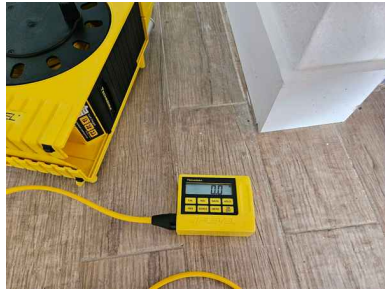
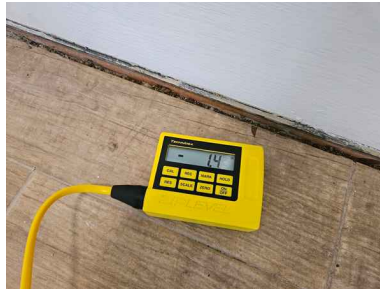
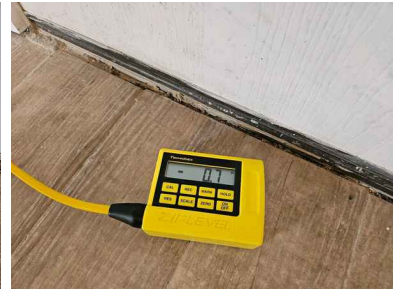
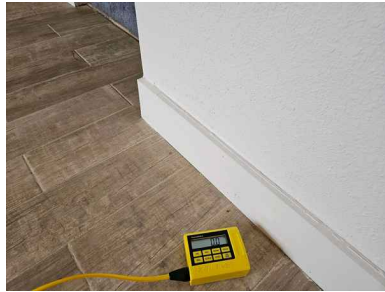
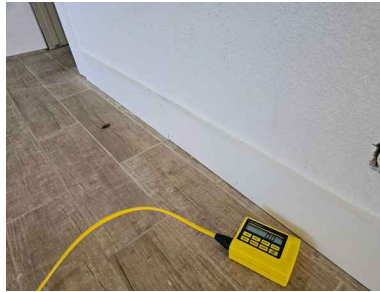
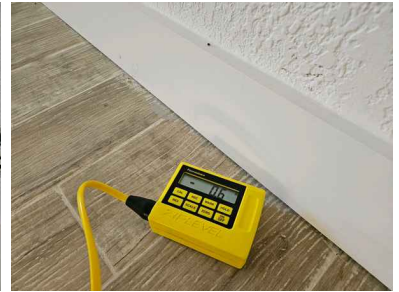
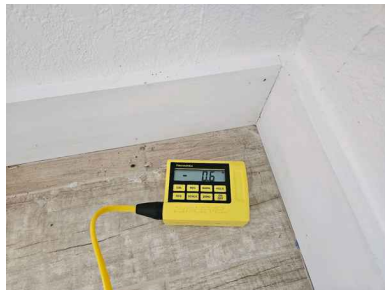
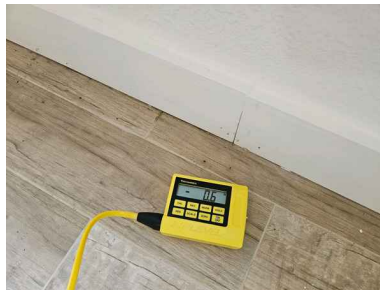
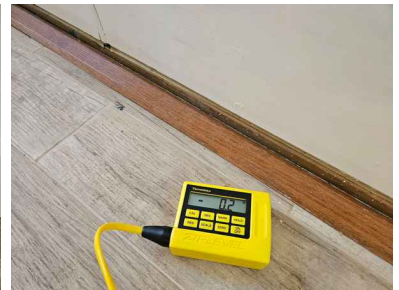
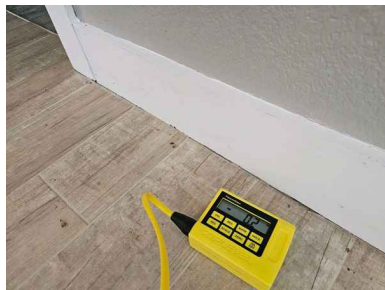
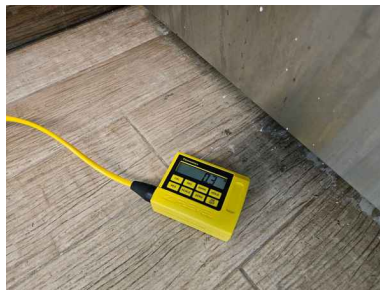
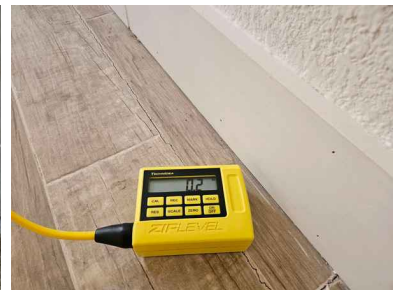
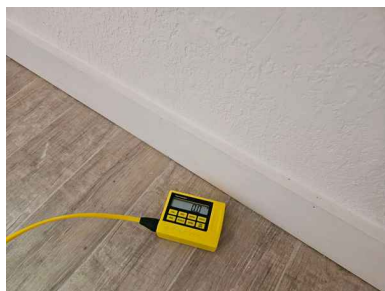
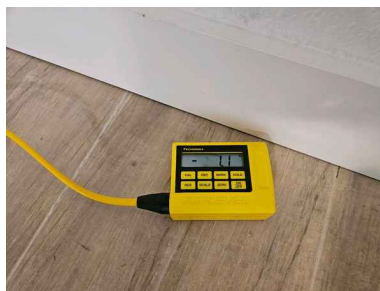
*Evidence of settling:*

**While the inspector does believe that the foundation is adequately supporting the structure at the time of the inspection, there are indications in the subsequent sections of this report that there has been settling occurring over the years. If client has current concerns regarding the foundation performance, it is recommended that a qualified, licensed structural engineer further evaluate prior to closing.**

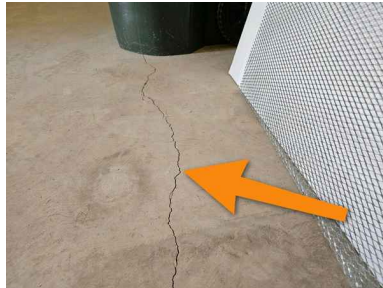
Garage

**1: Flatwork: Cracks****➡Further Evaluation Recommended**

Cracks were observed at the concrete flatwork in one or more locations. These cracks may indicate differential movement or settlement of the foundation. It is recommended that a qualified contractor further evaluate and repair or replace as needed.

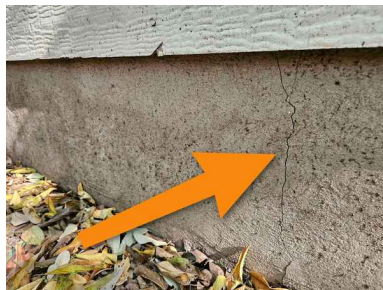
South side of house

**2: Perimeter beam: Small fracture / crack****➡Further Evaluation Recommended**

A fracture or crack was observed in one or more locations of the foundation perimeter beam at the time of the inspection. Cracks in concrete are common; however, if they widen over time, they may indicate movement, settlement, adverse foundation performance, or another defect. It is recommended that the crack(s) in the foundation perimeter beam be monitored for future movement.

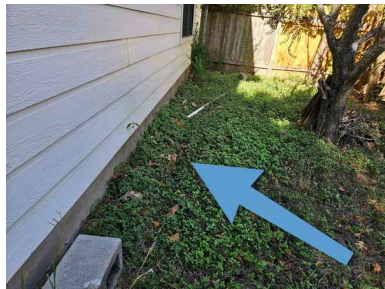
North and south sides of house

**1: Drip line: Developing****🔧 Maintenance or Recommendation**

A drip line was observed to be developing along the house at the time of the inspection. A drip line is the result of erosion from rain water running off of the roof. Drip lines may result in water collecting near the foundation, negative drainage or drainage related issues.

Areas where the grade does facilitate water away from the structure is to be considered an area of improper drainage. The ideal slope away from the foundation is 6 inches per the first 10 feet. It is recommended to monitor the drip line area(s) and if grading issues begin to occur, contact a qualified landscaper or qualified contractor to regrade so water flows away from the structure.

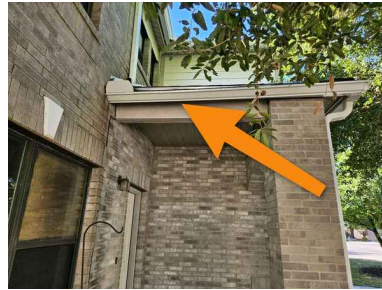
**2: Gutter: Not properly sloped / not level****🔧 Further Evaluation Recommended**

The gutter system was found to be improperly mounted / angled in one or more locations. Gutters that are not properly sloped or gutters that have negative slope may not perform as intended. It is recommended that a qualified gutter specialist further evaluate and repair as needed.

Gutter improperly sloped at front of house

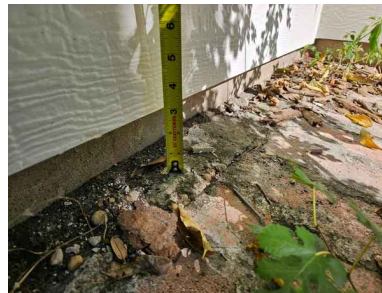
Back of house

**5: Soil / landscaping / building material: Level high at foundation**

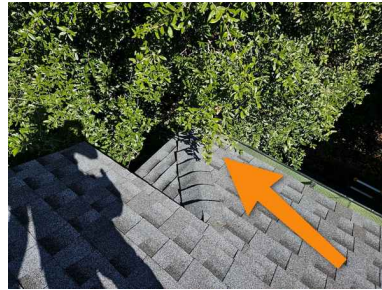
Various locations at south side of house

**1: Foliage: In contact or close proximity to roof covering material****➡ Further Evaluation Recommended**

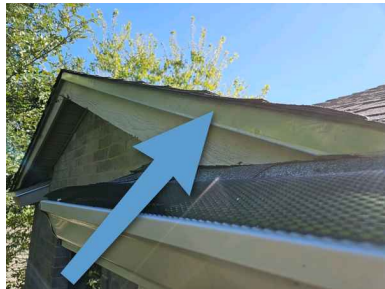
Drip edge flashing

**2: Roof flashing paint: Not present**

Paint was found to be missing at the flashing in one or more locations. Flashing is a thin material, often made from metal like aluminum or galvanized steel and installed at or near areas that can come into direct or indirect contact with water. Flashing helps direct water over or around areas that should not be exposed to water. It is recommended to have and keep a good coat of paint on the flashing to help minimize UV and rust damage.

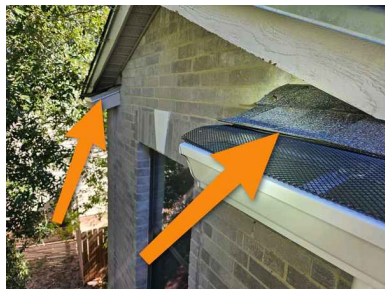
Small sections at front of house - photo

**3: Underlayment: Not present**

Underlayment was found to be missing in one or more locations. Underlayment serves as a secondary moisture barrier between the roof decking material and the shingles. It helps to prevent water intrusion and damage to the roof decking material should water find its way below the shingles. The absence of underlayment can lead to deterioration of the roof decking or surrounding material. It is recommended that a qualified roofer further evaluate and repair or replace as needed.

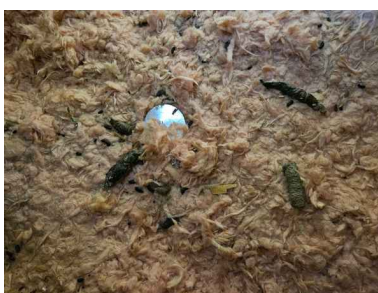
Evidence of rodent other animal activity was observed in one or more locations in the attic area. It is recommended to make sure that all eaves, frieze boards, chimney areas, etc. are properly sealed in order to reduce rodent / animal like activity in the attic space and to monitor these areas for any changes. It is recommended that a qualified contractor further evaluate and repair or replace as needed.

Animal droppings at various locations  
in attic area

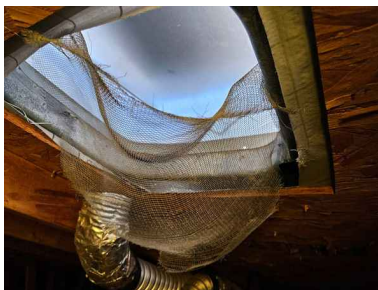
A roof vent screen in one or more locations was found to be damaged at the time of the inspection. Screens at vents help reduce insect and rodent intrusion. Damaged roof vent screens may not perform as intended. It is recommended that a qualified contractor further evaluate and repair or replace as needed.

Multiple screens damaged at roof vents  
in attic area

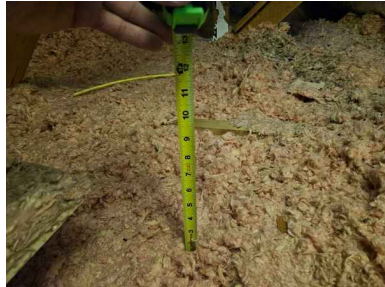
Insulation was found to be missing, found to be of an inadequate depth, not properly installed or have a void between the insulation and drywall material in the attic area in one or more locations. Missing or inadequate attic insulation depth may allow greater than normal loss of energy from inside the home.

**The recommended minimum blown insulation thickness is about 12 inches to achieve an R-38 value for attic areas in Central Texas.**

Approximately 2-4 inches of insulation present in attic area

It is recommended that a qualified contractor further evaluate and repair as needed.

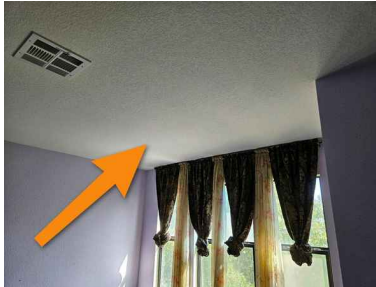
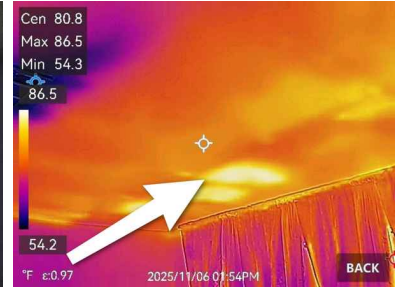
Above primary bedroom - thermal imaging

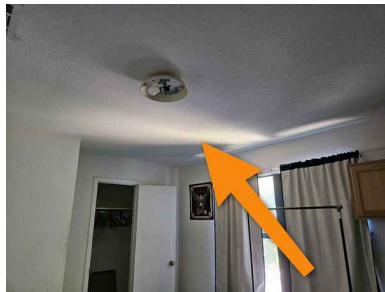
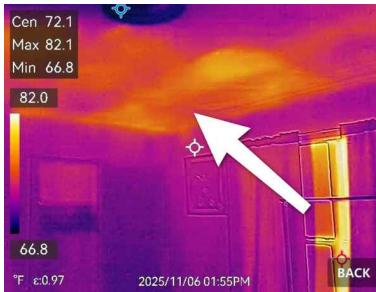
Above bedroom at northwest corner of house - thermal imaging

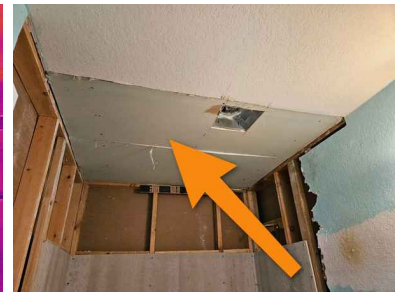
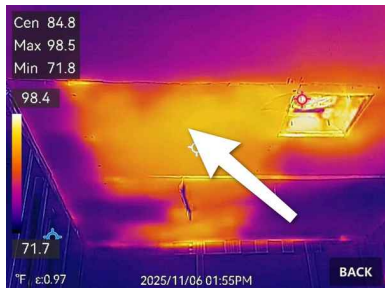
Above upstairs bathroom - thermal imaging

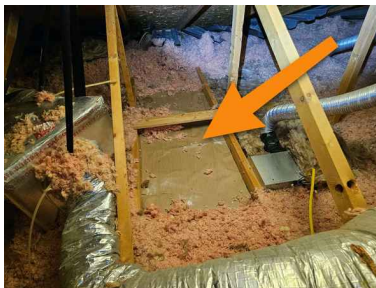
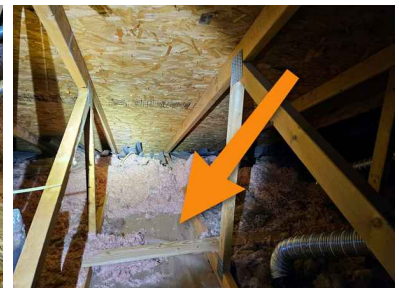
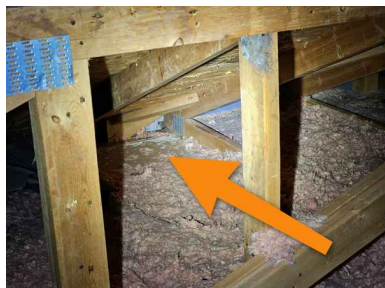
Exposed drywall at various locations in attic area

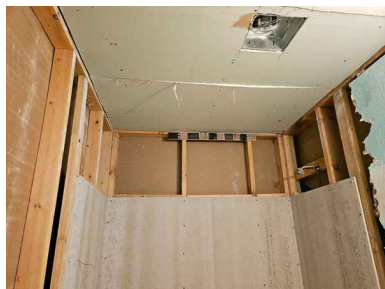
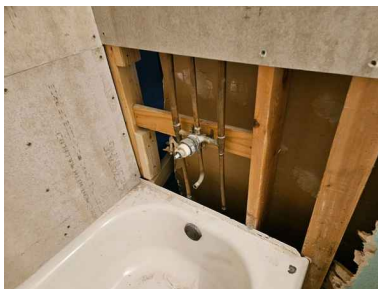
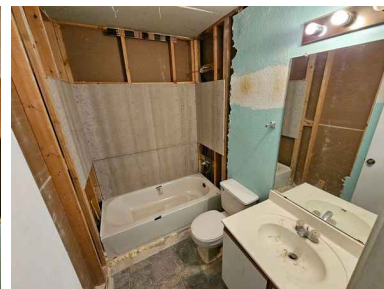
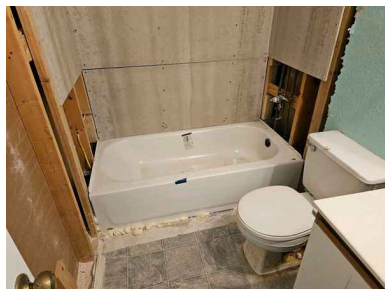
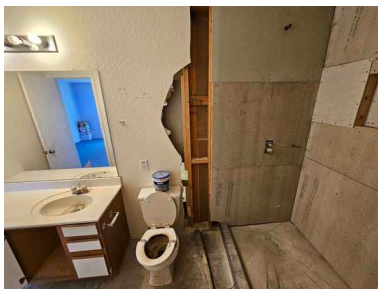
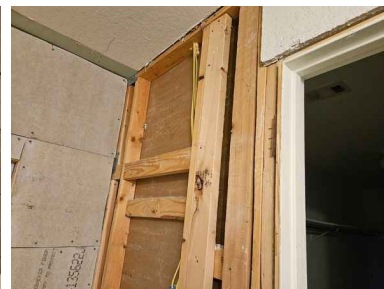
Multiple locations

One or more area of drywall was found to be unfinished at the time of the inspection. It is recommended that the drywall be finished by a qualified contractor.

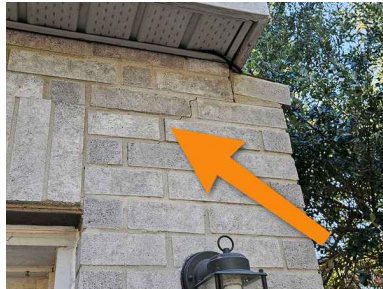
Southwest corner of house

Cracks were observed in the exterior brick/stone veneer walls. Cracks in exterior brick/stone veneer can be indications that some movement or settlement has or is occurring. It is recommended that cracks in the exterior walls be repaired by a qualified contractor and closely monitored.

If current or future concerns arise regarding the cracks, it is recommended that a structural engineer further evaluate prior to closing.

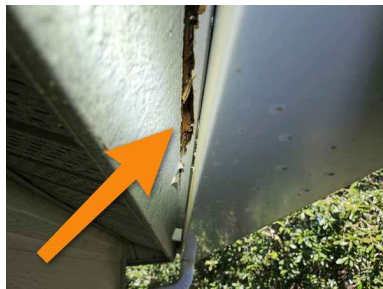
Exterior trim was deteriorated and/or damaged in one or more locations at the time of the inspection. Deteriorated and/or damaged trim should be repaired to prevent further damage, reduce moisture penetration and reduce insect intrusion at these locations.

Behind gutter system at various locations at front of house

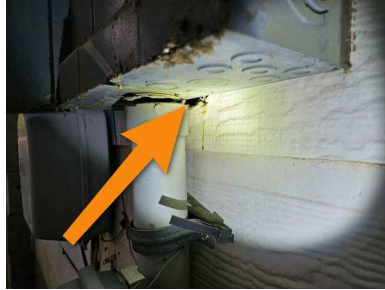
Northwest corner of house below main electrical panel

At the time of the inspection, sealants/caulking in one or more location was found to be separated, missing or deteriorated in one or more locations. Sealants/caulking help to reduce moisture

Sealant/caulking that has separated, experienced damage or that has deteriorated may indicate the sealant or surrounding material has or is experiencing settling or seasonal movement, an improper installation of the sealant or other reasons.

It is recommended that a qualified contractor further evaluate and repair as needed.

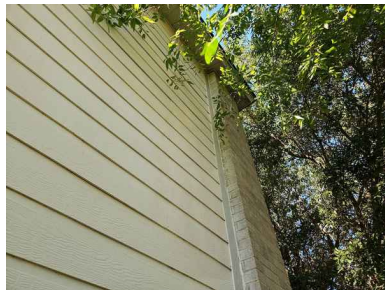
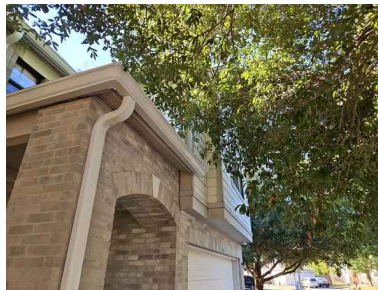
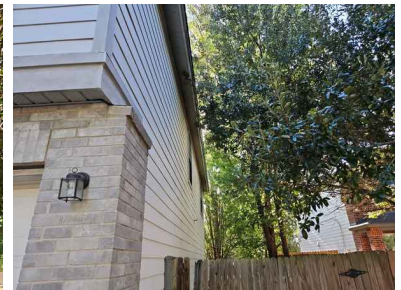
Multiple locations

Foliage was found on and/or in close proximity to the exterior structure. Heavy foliage at exterior surfaces can damage exterior veneer, create conducive conditions for wood destroying insects and can trap moisture. It is recommended that the foliage be trimmed away from structure at least 18 inches.

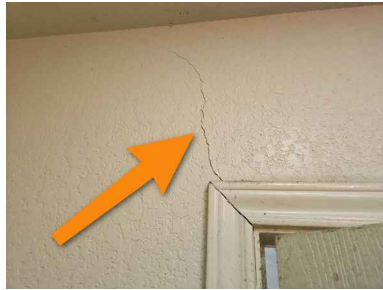
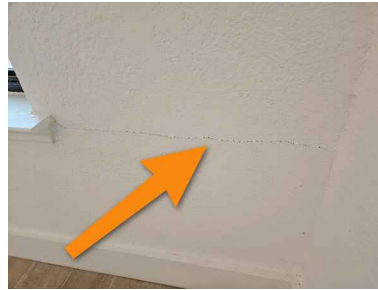
Multiple locations

Interior wall cracks were observed on the drywall material at the time of the inspection. Interior wall cracks can be an indication that there is or was some degree of movement or settling occurring in the structure. It is recommended to repair the cracked area and to monitor for continued movement. If continued cracking is observed, it is recommended to have a licensed structural engineer further evaluate.

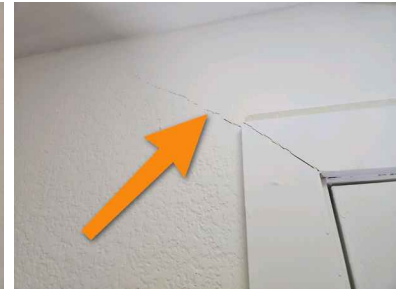
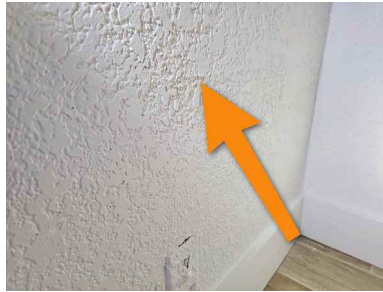
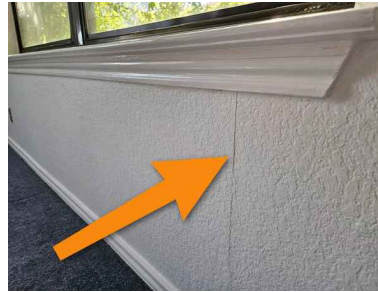
Multiple locations

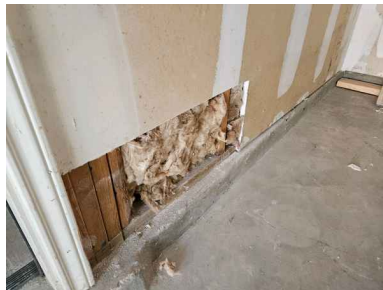
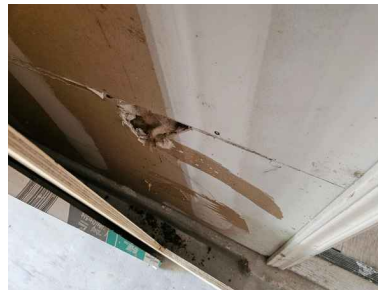
Various locations in garage

#### 8: Interior wall: Fungal growth

A fungal growth or fungal like substance appeared to be on a wall in one or more locations. Fungal growth can cause deterioration of construction materials and in some cases, attribute to adverse health conditions. The reason for the growth is unknown to the inspector. It is recommended that a qualified contractor further evaluate and repair as needed.

If current or future health concerns arise regarding the growth, it is also recommended that a mold remediation specialist further evaluate the area(s) of concern.

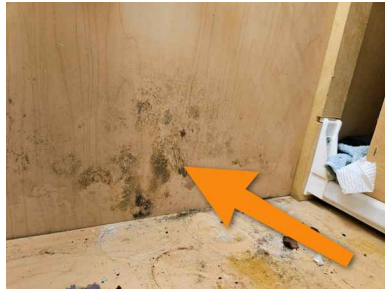
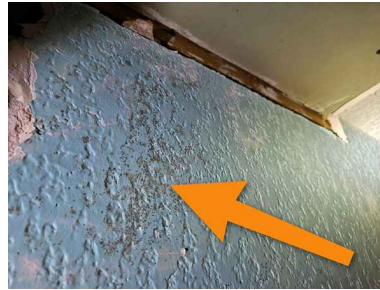
Below downstairs half bathroom sink

Upstairs hallway bathroom

**9: Lintel: Not present, damaged or not properly installed**

One or more lintels were found to be missing, damaged or improperly installed at the time of the inspection. Lintels are steel plates that help support the masonry material above openings such as windows and doors. When lintels are missing, damaged or improperly installed, the supporting lintel may bow over time due to the added weight from above or may not perform as intended and cause damaged to surrounding building material.

The lintels shall have a length of bearing not less than 4 inches (102 mm). Steel lintels shall be shop coated with a rust-inhibitive paint, except for lintels made of corrosion-resistant steel or steel treated with coatings to provide corrosion resistance. It is recommended that a qualified contractor further evaluate and repair or replace as needed.

IRC (International Residential Code) R703.8.3

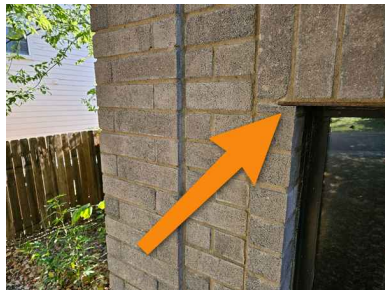
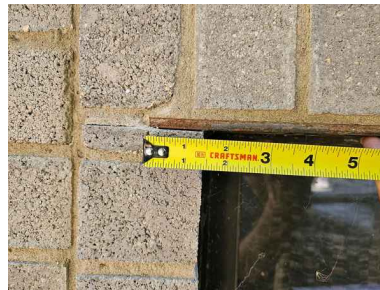
Left of entryway - photo 1

Left of entryway - photo 2

**10: Lintel: Unpainted or rusted**

A lintel was found to be unpainted or rusted in one or more locations. Lintels are steel plates that help support the masonry material above openings such as windows and doors. Unpainted lintels can begin to rust and can cause damage and/or cracking to the surrounding exterior wall masonry material as the rust begins to expand. It is recommended that the rust be removed (if applicable) and the lintels be painted to help prevent further damage or rust.

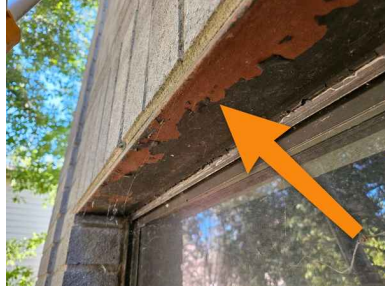
Multiple locations

**11: Siding: Deteriorated or damaged**

Siding was found to be deteriorated and/or damaged in one or more locations at the time of the inspection. Deteriorated or damaged siding should be repaired to prevent further damage, reduce chances of moisture penetration and reduce chances insect intrusion at these locations. It is recommended that a qualified contractor further evaluate and repair as needed.

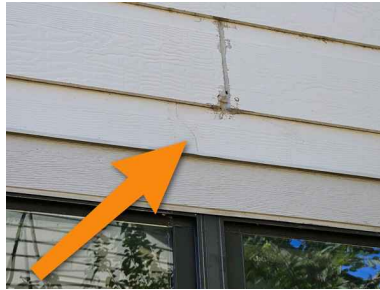
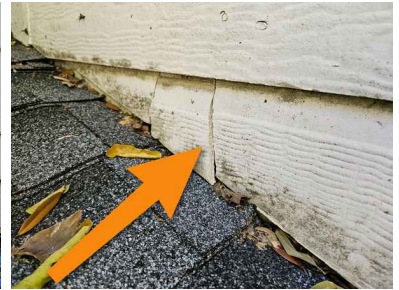
Multiple locations

**12: Siding or trim: In contact or in close proximity to roof covering material**

At the time of the inspection, exterior siding or trim was found to be in contact or in very close proximity to the roof covering material. When exterior siding or trim is in contact with the roof covering material, moisture can begin to wick up into the siding which may lead to deterioration and/or shorten the lifespan of the siding material. A small gap that provides adequate clearance is recommended between the two building materials. It is recommended that a qualified contractor further evaluate and repair as needed.

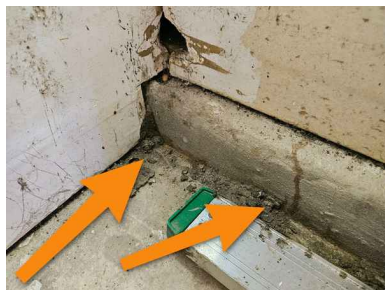
Garage near water heater

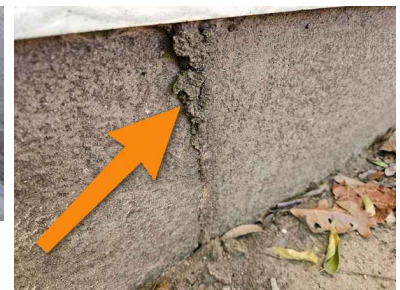
Mud tube at northwest corner of house

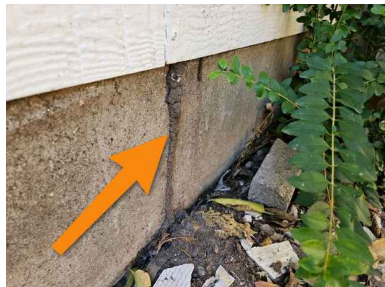
Mud tube at north side of house

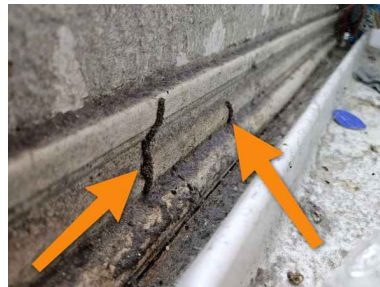
Mud tubes in laundry room behind washing machine

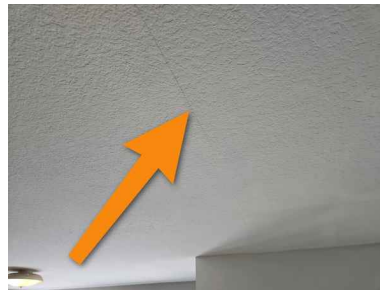
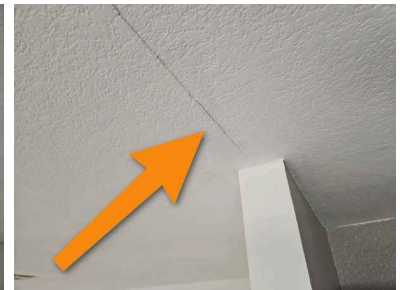
Multiple locations

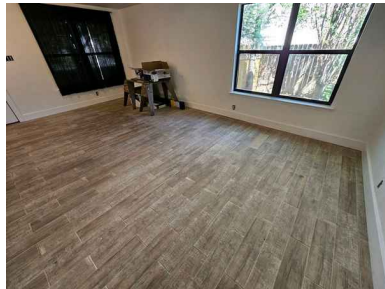
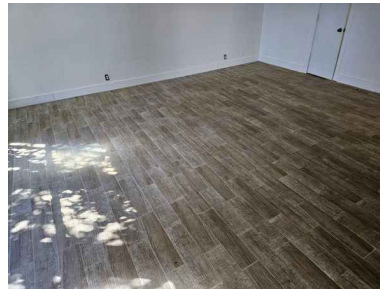
Multiple locations downstairs

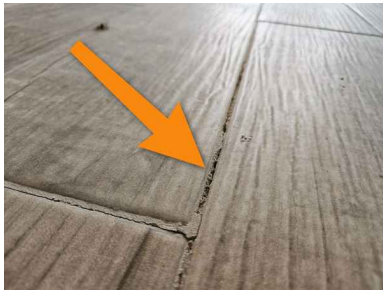
Multiple locations

### 8: Floor tiles: Cracked

A crack in the floor tile was observed in one or more locations at the time of the inspection. Cracked floor tiles can be attributed to an installation defect, some degree of movement or settling occurring at that location or other reasons. It is recommended that a qualified contractor further evaluate and repair or replace as needed. It is also recommended to monitor the area after repairs have been made.

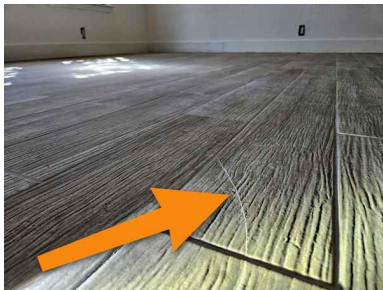
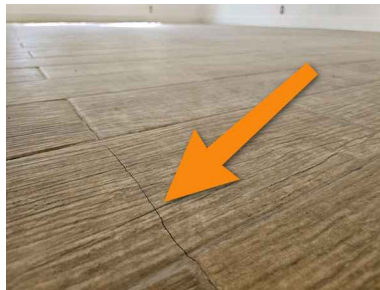
Living room near kitchen

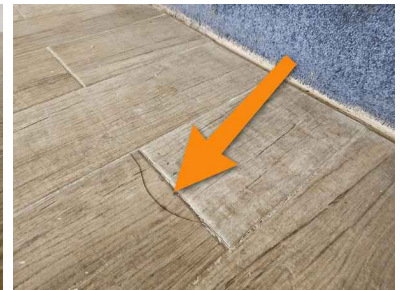
Bottom of staircase

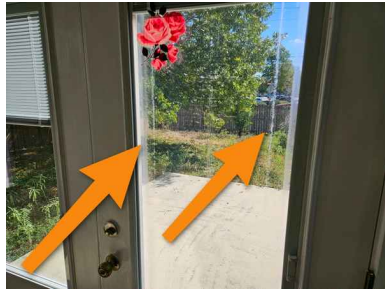
Back door

**4: Door: Misaligned and / or not properly opening or closing**

A door was found to be misaligned in one or more locations and/or does not properly open or close at the time of the inspection. Misaligned doors should be adjusted so that they freely open and shut. It is recommended that a qualified contractor further evaluate and repair as needed.

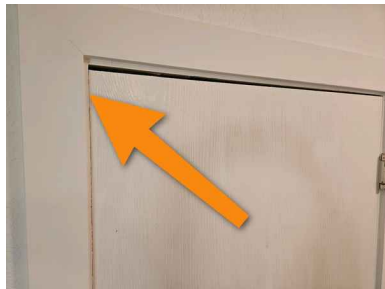
Contact at door to garage

**5: Door: Not present**

One or more door was found to not be missing/not installed at the time of the inspection.

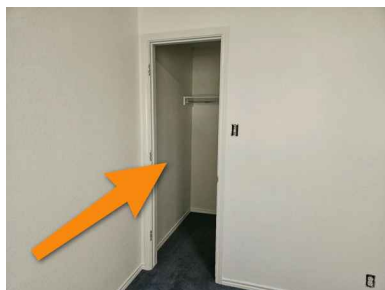
Closet door at upstairs front bedroom

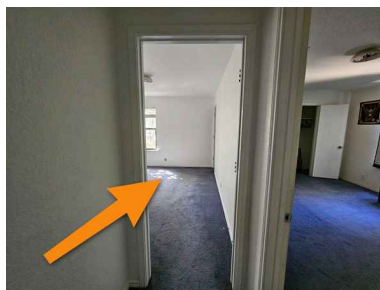
Door to upstairs bedroom at southwest corner of house

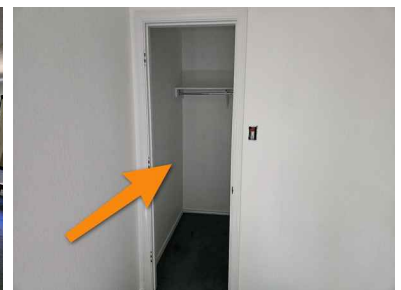
Closet door at upstairs bedroom at southwest corner of house

**6: Door threshold: Damaged**

function as intended and may not provide a solid seal below the door to help reduce moisture penetration or energy loss. It is recommended that a qualified contractor further evaluate and repair as needed.

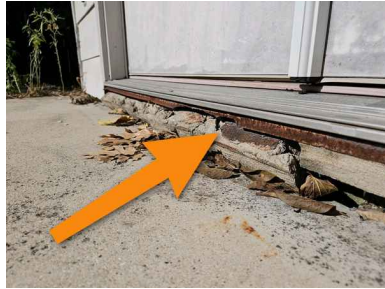
Threshold support below back door

#### 7: Hardware: Does not lock

The door lock or locking hardware was found to not function at one or more location. It is recommended that a qualified contractor further evaluate and repair as needed.

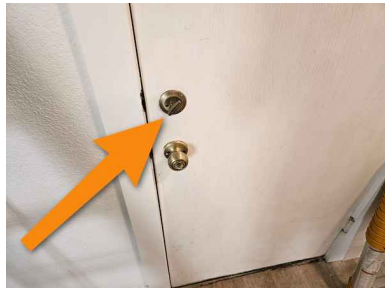
Deadbolt at door to garage

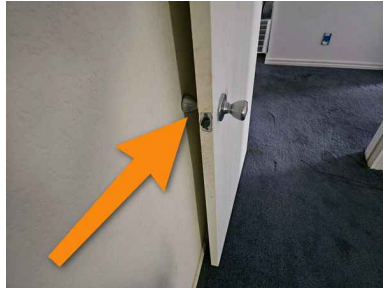
A door stop was observed to be missing, damaged or improperly installed in one or more locations. Door stops help to prevent impact damage and contact from occurring to the adjacent wall, fixtures or material. It is recommended that a qualified contractor further evaluate and repair or replace as needed.

Multiple locations

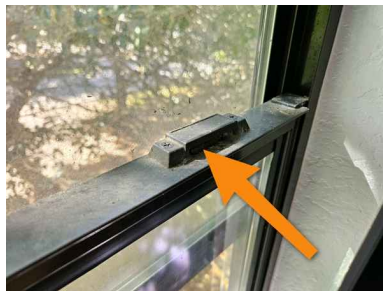
A lock in one or more locations was found to be damaged or difficult to operate/latch. It is recommended that a window specialist further evaluate and repair or replace as needed.

Bedroom window at southwest corner of house

**2: Screen: Damaged or not properly installed**

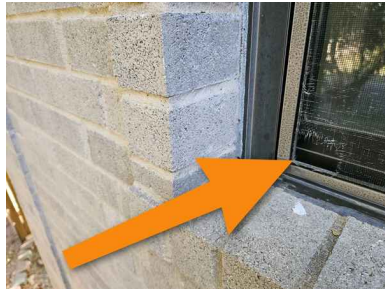
Upper window at front of house

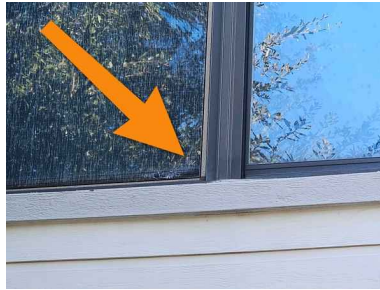
One or more window screen was found to be damaged or not properly installed in one or more locations. Window screens help prevent insect intrusion and can also prevent minor impact damage to the window.

Upper window at front of house

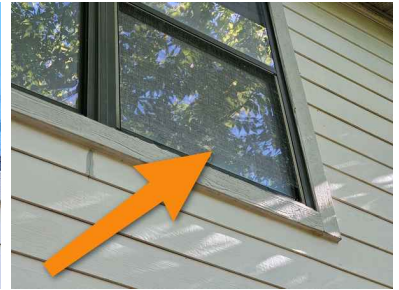
Upper window at southeast corner of house

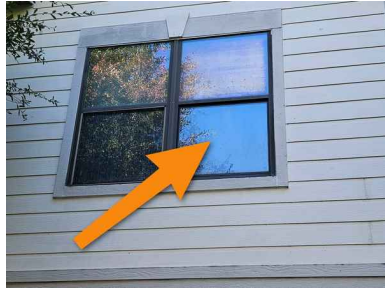
**3: Screen: Missing**

One or more window screen was observed to be missing at one or more windows. Window screens help prevent insect intrusion when the windows are open and can also prevent minor impact damage to the window.

Upper window at front of house

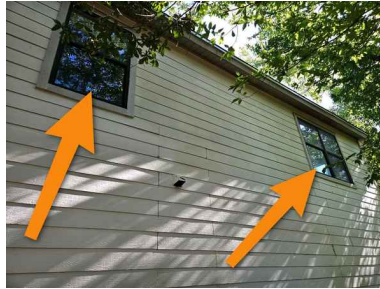
South side of house

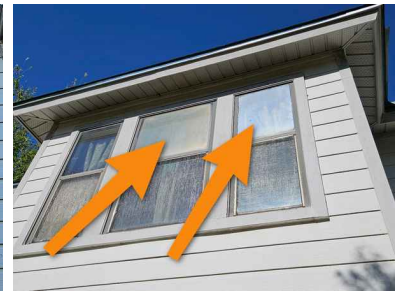
**5: Window: Markings / discoloration observed at glazing material****Further Evaluation Recommended**

Markings and/or discoloration were observed at the window glazing (glass) material in one or more locations at the time of the inspection. The marking/discoloration could be attributed to foreign debris, an installation defect, manufacturing defect, previous moisture penetration or early signs of loss of thermal seal.

Upper windows at back of house

When a thermal seal is lost, condensation will typically develop between the panes of glass which can cause discoloration or fogging. Discoloration or fogging may appear and disappear as humidity and temperature change during the seasons. It is recommended that a qualified window specialist or qualified contractor further evaluate and repair or replace as needed.

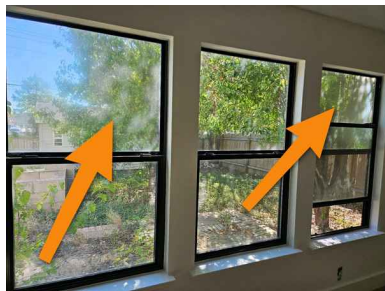
Downstairs living room at the back of house

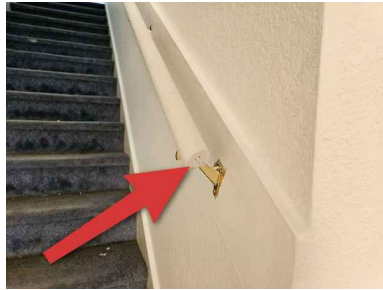
**1: Handrail: Improperly terminated****Safety Hazard**

The handrail for the stairway was observed to not properly terminate. Under current building standards, handrails should return to the wall or to a post. This is considered to be a SAFETY HAZARD.

Bottom of staircase

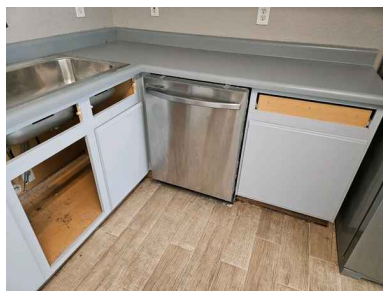
Cabinetry in one or more locations was found to be incomplete or unfinished at the time of the inspection. It is recommended that a qualified contractor further evaluate and repair as needed.

Kitchen

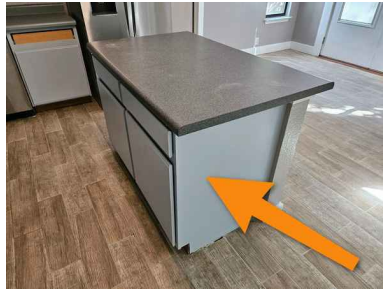
**2: Cabinetry: Not properly installed**

Cabinetry was found to be improperly installed in one or more locations at the time of the inspection. It is recommended that the cabinetry be repaired by a qualified contractor.

Kitchen island loosely installed

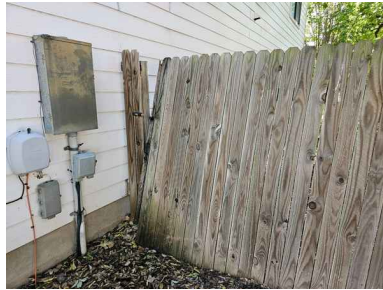
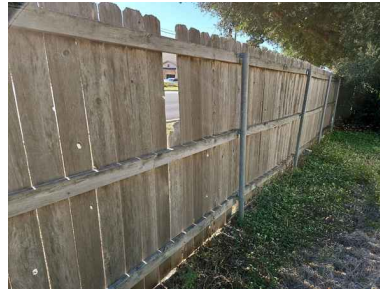
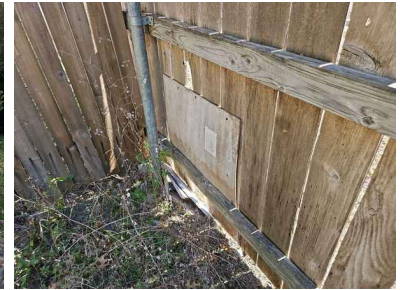
**3: Fence panel(s), picket(s) or post(s): Damaged or not properly installed**

One or more section of the fence panel(s), pickets(s) or post(s) were found to be damaged or not properly installed at the time of the inspection. Fence panels, pickets or posts that are damaged or improperly installed may lead to bowing/wavy fences or can become detached from adjacent material. It is recommended that a qualified contractor further evaluate and repair as needed.

Multiple locations

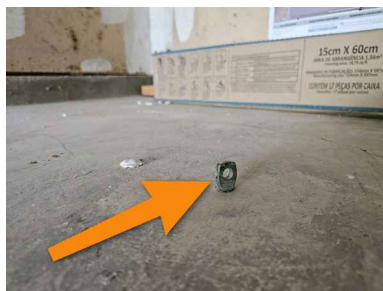
**4: Flatwork: Foreign debris adhered or embedded in concrete**

Construction material or other foreign debris was found on the concrete flatwork. It is recommended that the concrete flatwork be repaired and/or cleaned by a qualified contractor.

Garage near sub panel

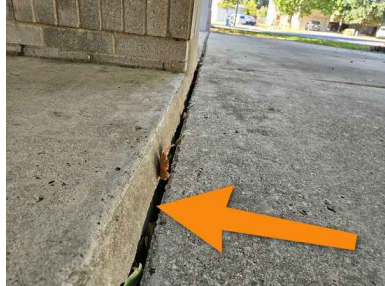
**5: Wooden expansion joint for concrete flatwork: Deteriorated or not present**

At the time of the inspection, a wooden (or similar material) expansion joint was found to not be installed at the concrete flatwork in one or more locations.

Concrete walkways, driveways and steps can move depending on weather, water or other elements. Expansion joints allow minor expansion/contraction and helps minimize cracking that may occur at these locations and also helps to reduce water penetration at these locations. It is recommended that a qualified contractor further evaluate and repair as needed.

Entryway

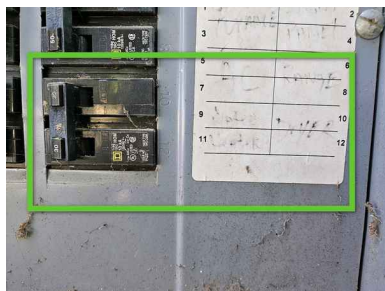
*Pre 2020 NEC change: 240v receptacle(s) not GFCI protected:*

This home was likely constructed before this standard. According to article 210.8(A)(10) which includes laundry rooms of the 2020 National Electric Code (NEC):

Breaker for dryer at main panel

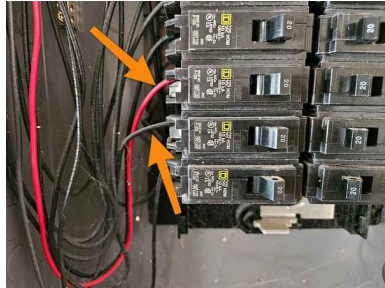
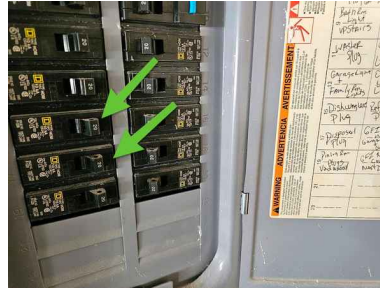
Breaker in one or more locations were found to be missing handle ties or a tandem breaker. The split breaker(s) servicing 120 or 240 volt appliances sharing a neutral conductor should be connected together by a

Wires for dishwasher and garbage disposal breakers share neutral wire in sub panel - photo 1

Wires for dishwasher and garbage disposal breakers share neutral wire in sub panel - photo 2

breaker tie or a tandem breaker. It is recommended that a qualified, licensed electrician further evaluate and repair or replace as needed.

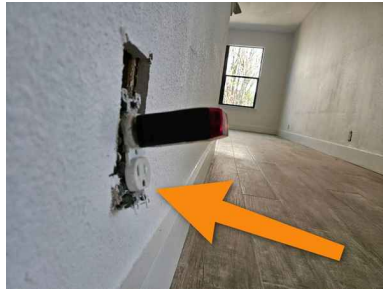
**2: Electrical receptacle: Loose**

One or more receptacles were found to be loose at the time of the inspection. Loose or unsecured receptacles can lead to wiring damage or electrical shorts. It is recommended that a qualified, licensed electrician further evaluate and repair or replace as needed.

Multiple locations

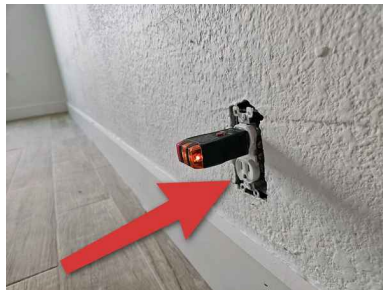
### 3: Faceplate: Not present

One or more faceplates were found to be missing. Missing faceplates are considered to be a SAFETY HAZARD and should be repaired by a qualified contractor.

Multiple faceplates

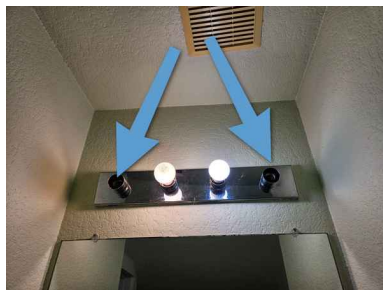
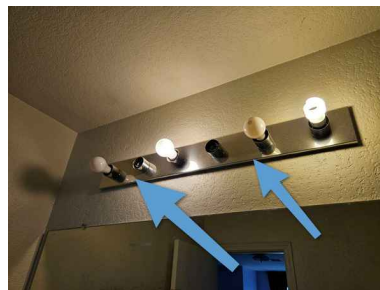
### 4: Light bulb: Not present

A light bulb was found to be missing in one or more locations at the time of the inspection.

Half bathroom

Primary bathroom

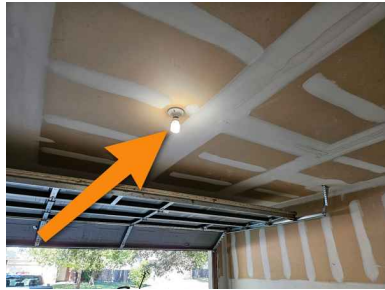
### 5: Light bulb: Unprotected

A light bulb in one or more locations was found to be installed without a protective globe or a protective casing. It is recommended that a qualified contractor further evaluate and repair or replace as needed.

Garage

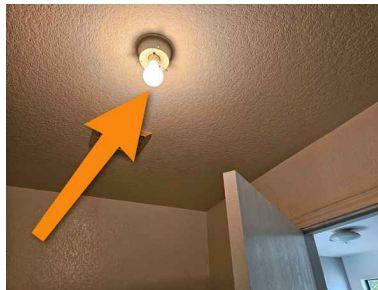
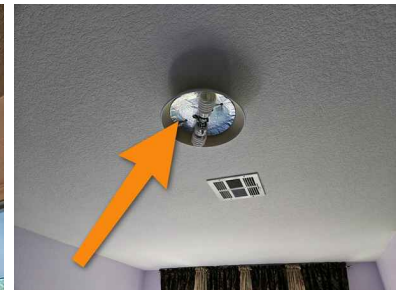
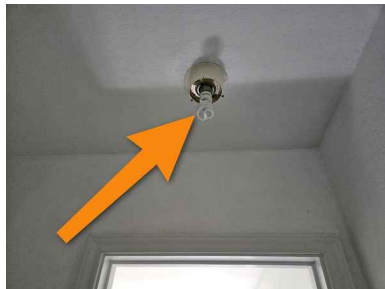
**6: Light fixture cover: Not present**

At the time of the inspection, a light fixture cover was found to be missing in one or more locations. Light fixture covers help protect light bulb(s) and wiring from outside contact. It is recommended that a qualified contractor further evaluate and repair or replace as needed.

Utility room

Primary bedroom

In bedroom closet at southwest corner of house

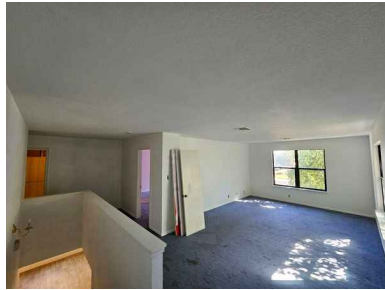
**7: Light fixture: Not present**

A light fixture was found to be missing at the time of the inspection. It is recommended that a qualified contractor further evaluate and repair or replace as needed.

Upstairs family room

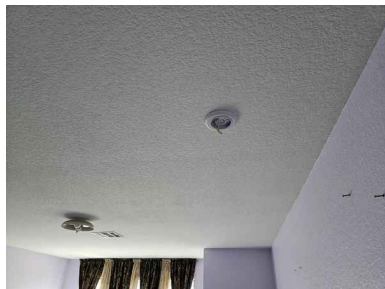
**9: Smoke alarm: Not present**

A smoke alarm was found to be missing in one or more locations at the time of the inspection. Under current building standards, there should be a smoke alarm located in every bedroom, adjoining areas outside of bedrooms and on each habitable level of the home. This is considered to be a SAFETY HAZARD. It is recommended that a qualified contractor further evaluate and repair or replace as needed.

Multiple smoke alarms missing

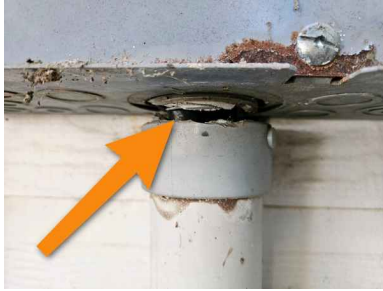
**10: Wiring conduit: Loose or not properly installed**

Wiring conduit was found to be loose or improperly installed in one or more locations at the time of the inspection. Electrical conductors (wires) should be protected by conduit (in exposed locations such as outside of an attic space or outside of interior walls) to help reduce chances of damage occurring to the wire and to also help reduce potential shock hazards if the wire becomes damaged. Conduit should be properly attached to the structure or other building material to mitigate movement if accidental contact is made. It is recommended that a qualified, licensed electrician further evaluate and repair as needed.

Damaged conduit below main panel for  
service entrance cables

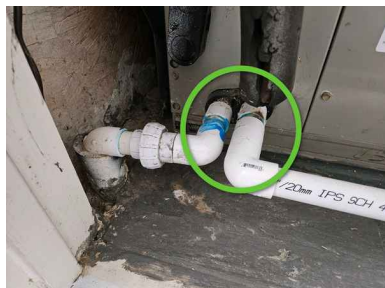
At HVAC unit

HVAC unit: Float switch at drain line recommended:

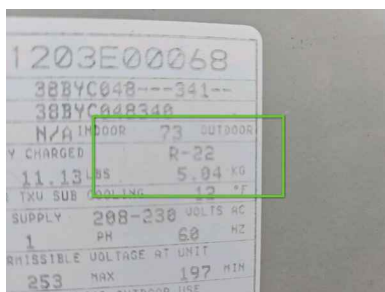
Label at condenser unit

*R22: Phase out notice:*

The A/C system uses R-22 type refrigerant. A general phase out of this refrigerant was completed by 2020 and manufacturers are no longer able to produce R-22 to service A/C units and heat pumps. Existing units can continue to use and be serviced with R-22 or recycled R-22 but may be more expensive and difficult to obtain as it is quickly becoming obsolete. Newer HVAC systems use a R-410 refrigerant.

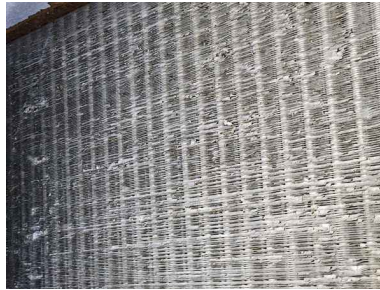
**1: Evaporator coil: Damaged****➡Further Evaluation Recommended**

At the time of the inspection, the evaporator coil was going to be damaged at the HVAC unit. A damaged evaporator coil may reduce cooling efficiency, shorten the life expectancy of the system or cause damage to the system. It is recommended that a qualified, licensed HVAC technician further evaluate and repair or replace as needed.

Damaged fins at evaporator coil in  
HVAC closet - photo 2

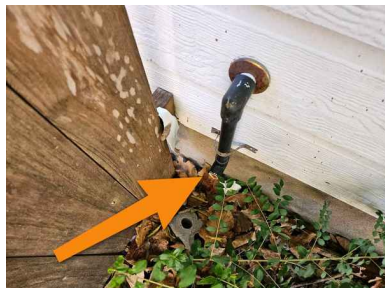
Northwest corner of house - photo 1

**4: Primary condensate drain line: Terminates near foundation**

The main/primary condensation line coming from the coil box was observed to terminate to the exterior of the home. Evaporator coils at HVAC units produce condensation when in cool mode. Condensate drain lines for HVAC units help move the condensation away from the HVAC unit.

When a main condensate drain line terminates to the exterior of the home, it can interfere with maintaining a constant moisture content around the perimeter of the foundation and can also become susceptible to debris clogging the end of the line. It is recommended that the main condensate line terminates into an interior sewer drain or an unobscured location approximately 5 feet away from the foundation.

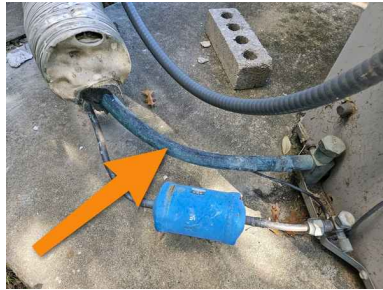
At the time of the inspection, insulation at the refrigerant line was found to be missing or not properly installed. Refrigerant lines at HVAC units can reach cold temperatures and will produce condensation if not properly insulated. Properly insulated refrigerant line can improve performance, help to prevent moisture from building on the exterior of the line and help reduce the chances of dripping condensate. It is recommended that a qualified, licensed HVAC technician further evaluate and repair or replace as needed.

Insulation not present at suction line  
near condenser unit

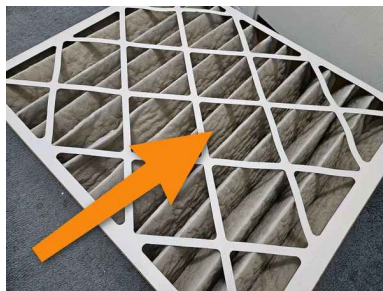
**1: Air filter: Dirty**

An air filter was found to be dirty in one or more locations at the time of the inspection. Dirty air filters can reduce the HVAC's overall efficiency, shorten the equipment's serviceable life and can also result in damage to the cooling equipment. It is recommended to replace dirty air filters.

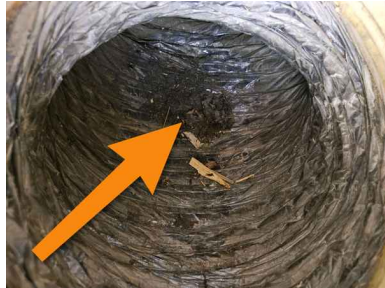
**2: Duct: Debris**

Ducting in one or more locations was found to have debris or an obstruction. Ducting should have unrestricted airflow throughout the house as restricted airflow may affect performance. It is recommended that a qualified HVAC technician further evaluate and repair as needed.

Debris at return ducting below HVAC unit

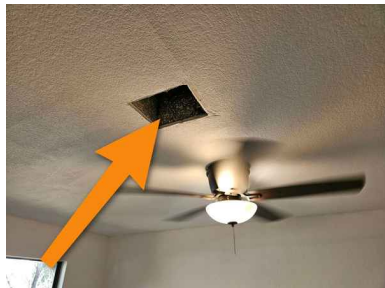
Downstairs living room

**3: Air supply register: Not present****➡Further Evaluation Recommended**

At the time of the inspection, one or more supply register was found to not be installed. Supply registers supply cool and warm air at different rooms and locations throughout the house from the HVAC unit. A room or location without a supply register may not reach desired temperatures. It is recommended that a qualified, licensed HVAC technician further evaluate and repair as needed.

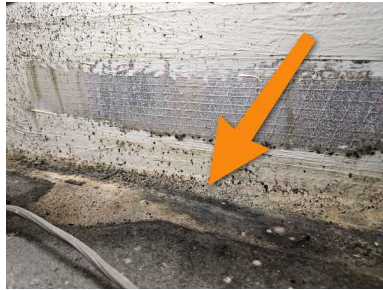
At HVAC closet

**4: Exterior plenum / duct connection: Fungal growth****➡Further Evaluation Recommended**

A fungal-like substance was found to be where the plenum and ductwork connect in one or more locations in the attic area. Moisture at these locations may be caused by excess humidity levels, improperly sealed/insulated ducts or other reasons.

Fungal growth can cause deterioration of construction materials and in some cases, attribute to adverse health conditions. Fungal growth at these locations is typically not a health hazard but should be removed to mitigate spreading of the fungal growth.

It is recommended that a qualified, licensed HVAC technician further evaluate and repair as needed.

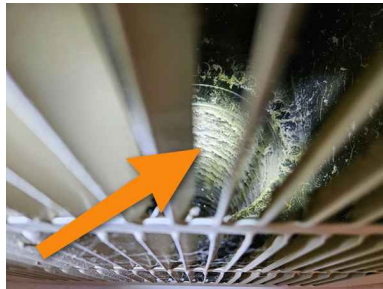
### 5: Return ducting: Dirty

Return ducting for the HVAC system was found to be dirty in one or more locations. Dirty return ducting can be an indication that the air filters were not changed frequently, are in need of changing or other reasons.

When air filters become dirty they can reduce the HVAC's overall efficiency, shorten the equipment's serviceable life and can also result in damage to the cooling equipment.

**NOTE: This area is located before the air filter.**

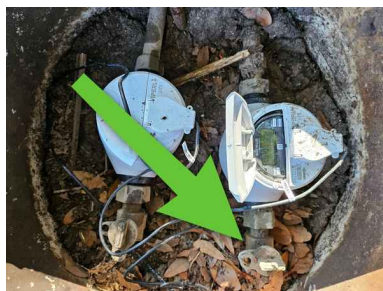
Supply valve: Turned off or in off position:

**At the time of the inspection, the main shut off valve was found to be in the off position and the plumbing fixtures were unable to be checked for functionality. Due to an active remodel, plumbing lines and plumbing valves not present, the plumbing supply remained in the off position during the inspection and may conceal defects that may have been observed if operated.**

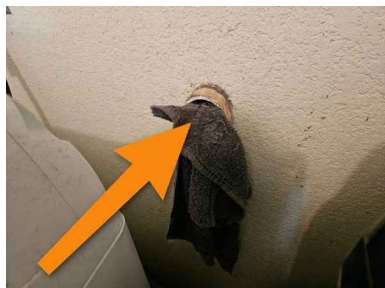
Utility room

**1: Drain cover: Damaged, missing or not properly installed****Further Evaluation Recommended**

One or more drain cover was found to be damaged, missing or not properly installed at the time of the inspection. Drain covers that are damaged, missing or not properly installed may not function as intended and allow oversized debris to enter into the drain system. It is recommended that a qualified contractor further evaluate and repair or replace as needed.

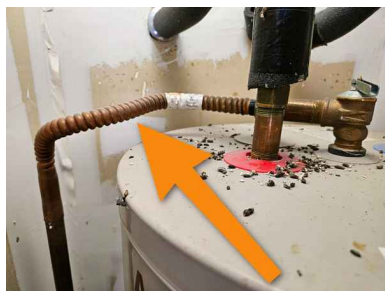
At the time of the inspection, a flexible line was found to be used for the TPR (temperature and pressure relief valve) drain line. TPR lines assist in removing excessively high temperature and/or excessively high pressurized water from the water heater to the outside of the structure in the event the water heater malfunctions. Under current building standards, TPR drain lines are to be installed without kinks or restrictions in the piping material. CPVC pipe, copper pipe or other material designed to withstand higher temperatures/pressures should be used as the TPR drain line.

[International Residential Code \(IRC\) 2804.6.1 \(3\)](#)

It is recommended that a qualified, licensed plumber further evaluate and repair or replace as needed.

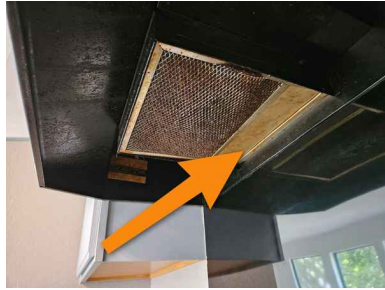
The light for the hood range and exhaust system was found to not be operating at the time of the inspection. It is recommended that a qualified contractor further evaluate and repair as needed.

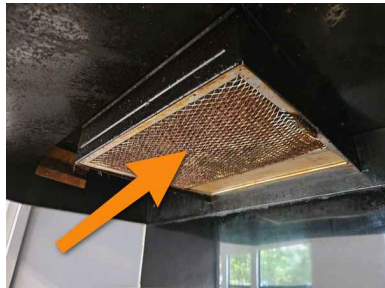
**2: Range hood filter: Dirty**

The filter for the range exhaust system was found to be dirty. Over time, filters can become clogged with grease and other cooking residues, reducing the range hood's effectiveness. It is recommended that the dirty filters be replaced or cleaned.

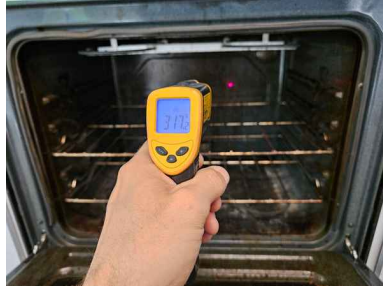
**1: Anti - tip device: Missing or damaged****⚠️ Safety Hazard**

The freestanding oven/range was observed to be missing an anti-tip device. A freestanding oven/range without an anti - tip device is considered to be a SAFETY HAZARD and should be repaired.

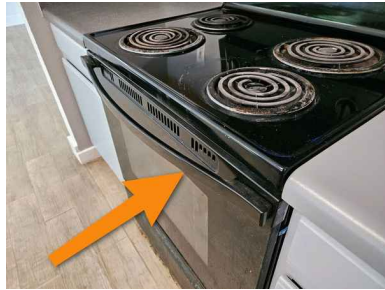
Handle loosely installed at oven

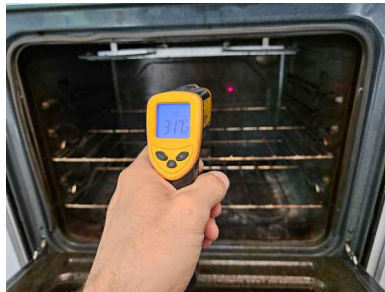
**4: Oven temperature: Out of recommended range**

The recommended temperature differential is +/- 25 degrees when set to 350 degrees. The oven temperature is out of the recommended range and may not perform as intended.

317 degrees

NOTE: When an oven's temperature is different from the desired temperature, homeowners can use an external thermometer that is installed on an oven rack to get a desired and accurate temperature instead of what is programmed within the oven.

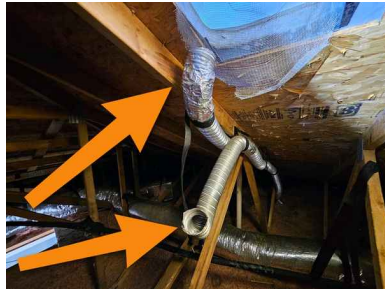
Above hallway bathroom in attic area

**1: Exhaust vent ducting: Loose and improperly sealed at attic decking****➡ Further Evaluation Recommended**

An exhaust vent duct was found to be loose and improperly sealed at the decking area in the attic in one or more locations. Ducting that is not properly sealed / connected may become loose over time resulting in mildew and/or organic growth and cause damage to the surrounding building materials. Mechanical exhaust vents should always vent to the exterior of the structure. It is recommended that a qualified contractor further evaluate and repair or replace as needed.
