TREC REI 7-6

179 Lexington  
Kyle, TX 78640

# PROPERTY INSPECTION REPORT FORM

| 179 Lexington, Kyle, TX 78640<br><i>Address of Inspected Property</i> | |

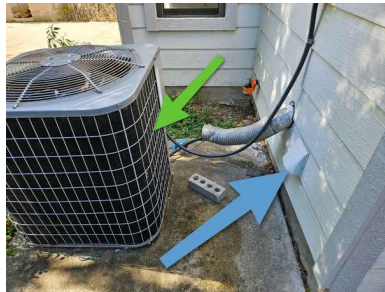
### 1: Dryer vent: Improperly terminated near AC condenser

Due to the proximity of the dryer vent termination and the AC condensing unit, it is recommended to monitor the condensing unit fins periodically as lint may find its way onto the outer sides of the fins. The AC condensing unit's fins should always be free of debris as clogged fins can reduce the condenser's efficiency.

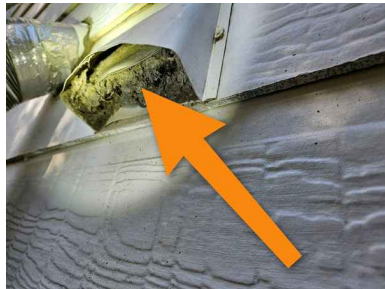
### 2: Dryer vent: Lint and/or debris build up

Lint and/or debris was found to be in the dryer vent area. Lint build up in dryer vents up can become a fire hazard and reduce the efficiency of the dryer.
